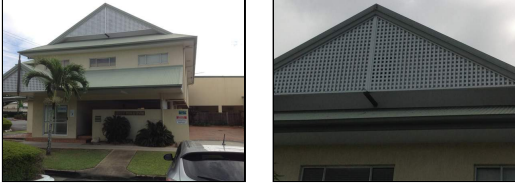
| Description of Area | Asbestos Location and Description | Sample Number | Condition | Friability | Accessibility | Risk Rating |
|--|--|---|---|---|---|---|
| Gables | Gable on southern elevation, behind lattice Cement sheet - 10m2 | 1 | Good | Non-friable | Medium | Low |

| Description of Area | Asbestos Location and Description | Sample Number | Condition | Friability | Accessibility | Risk Rating |
|--|--|---|---|---|---|---|
| | | | | Lab results & Control Recommendation: Chrysotile asbestos identified in samples Affix warning labels. Avoid mechanical damage and abrasion. Remove if reburishment, structural alteration or demolition is to be carried out in this area. Implement regular inspections, at least annually, or earlier if disturbed or removed. | | |

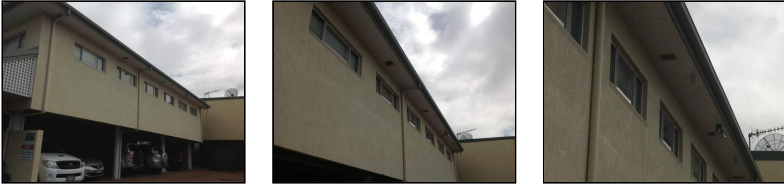
| Description of Area | Asbestos Location and Description | Sample Number | Condition | Friability | Accessibility | Risk Rating |
|--|--|---|---|---|---|---|
| Eaves | All building elevations Cement sheet - 30m2 | 2 | Good | Non-friable | Medium | Low |

| Description of Area | Asbestos Location and Description | Sample Number | Condition | Friability | Accessibility | Risk Rating |
|--|--|---|---|---|---|---|
| | | | | Lab results & Control Recommendation: Chrysotile asbestos identified in samples Affix warning labels. Avoid mechanical damage and abrasion. Remove if reburishment, structural alteration or demolition is to be carried out in this area. Implement regular inspections, at least annually, or earlier if disturbed or removed. | | |

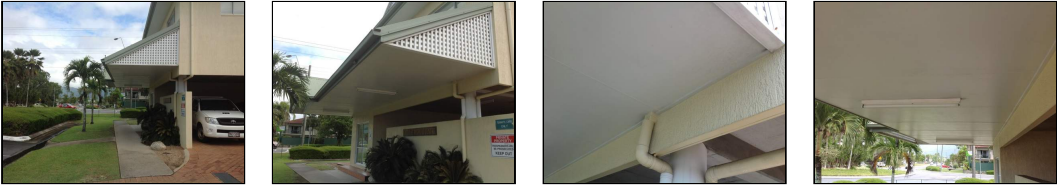
| Description of Area | Asbestos Location and Description | Sample Number | Condition | Friability | Accessibility | Risk Rating |
|--|--|---|---|---|---|---|
| Awnings | Front of building Cement sheet - 21m2 | 3 | Fair | Bonded | High | Low |

| Description of Area | Asbestos Location and Description | Sample Number | Condition | Friability | Accessibility | Risk Rating |
|--|--|---|---|---|---|---|
| | | | | Lab results & Control Recommendation: Chrysotile asbestos identified in samples Affix warning labels. Avoid mechanical damage and abrasion. Remove if reburishment, structural alteration or demolition is to be carried out in this area. Implement regular inspections, at least annually, or earlier if disturbed or removed. | | |
