Playground Inspection Report

Owner: XYZ Childcare Pty Ltd
Address: 106-114 Taylor Road Mooroolabrk
Date of Inspection: 23/02/2015

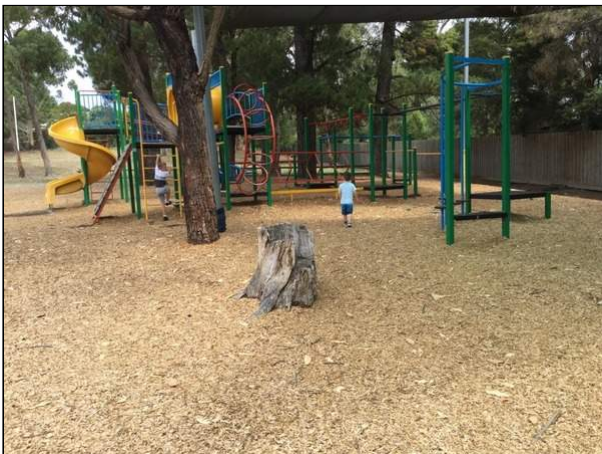
1. Is the play area clean and maintained?

Yes

Comment: Large amount of sand over surfaces

Priority: Low

Yes
Comment: Large amount of sand over surfaces
Action Required: Requires cleaning
Priority: Low

Action Required: Requires cleaning

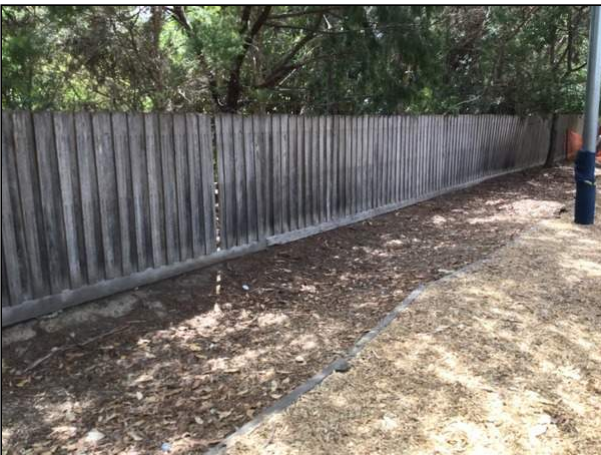
5. Are any external emergency or evacuation points free from obstruction?

No
Comment: Only for report example
Action Required: N/A
Priority: High

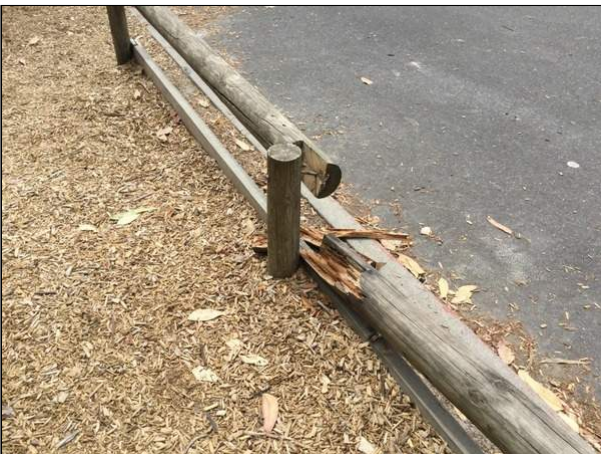
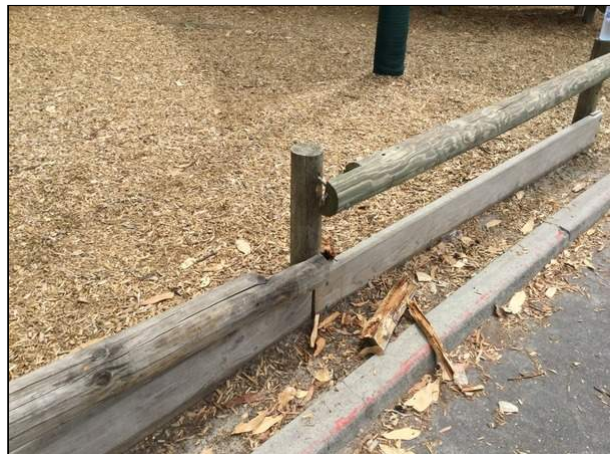
11. Are all wooden structures (structural and non-structural) free from rot, cracks and splinters?

No

Comment: Timber rail has been broken

Priority: Medium

No
Comment: Timber rail has been broken
Action Required: Replace or fix.
Priority: Medium

Action Required: Replace or fix.

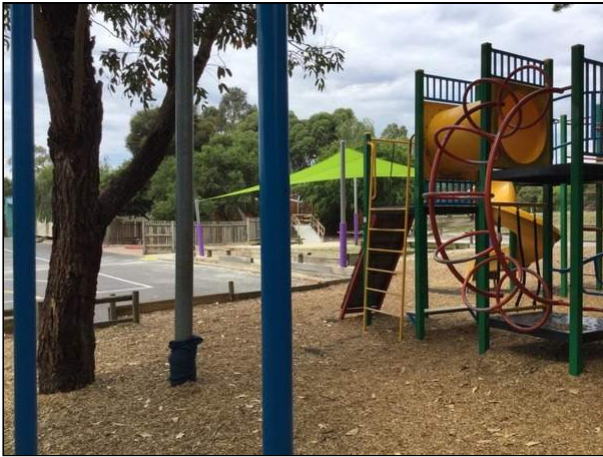
17. Does the soft fall comply with AS/NZS4422?

No

Comment: No soft fall test scheduled for this site
Action Required: Impact attenuation test required to confirm.

Priority: Medium

No
Comment: No soft fall test scheduled for this site
Action Required: Impact attenuation test required to confirm.
Priority: Medium

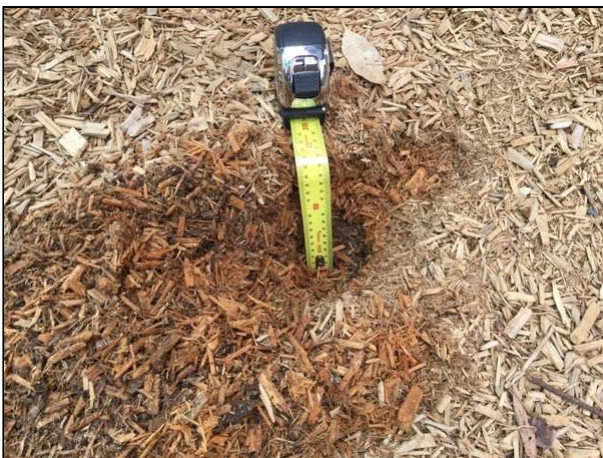
18. Is the depth of soft fall adequate for the material used?

No

Comment: Approx 150mm of bark in some areas, minimum requirement is 250-300mm. Only for report example

Priority: High

No
Comment: Approx 150mm of bark in some areas, minimum requirement is 250-300mm. Only for report example
Action Required: Top up soft fall in all required areas.
Priority: High

Action Required: Top up soft fall in all required areas.

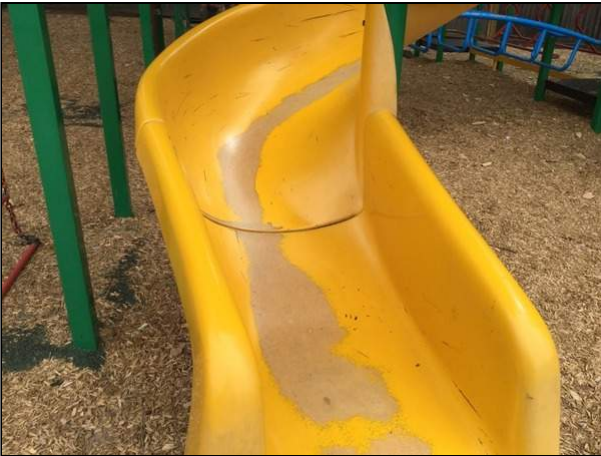
29. Are slides in good condition, securely attached and free from toggle entrapments as per AS4685 Part 1?

No
Comment: Slide is showing signs of wear.
Action Required: Replace slide when required.
Priority: Low

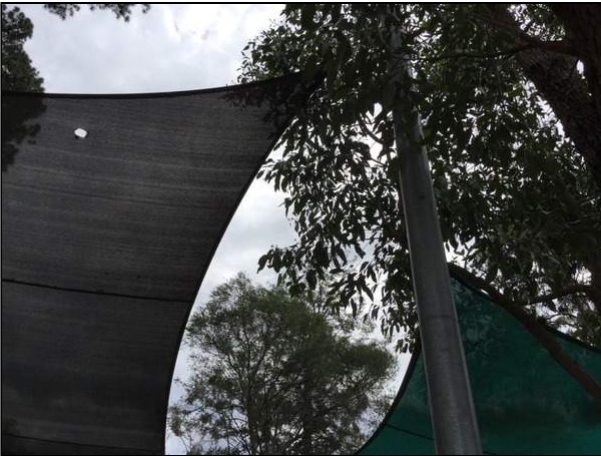
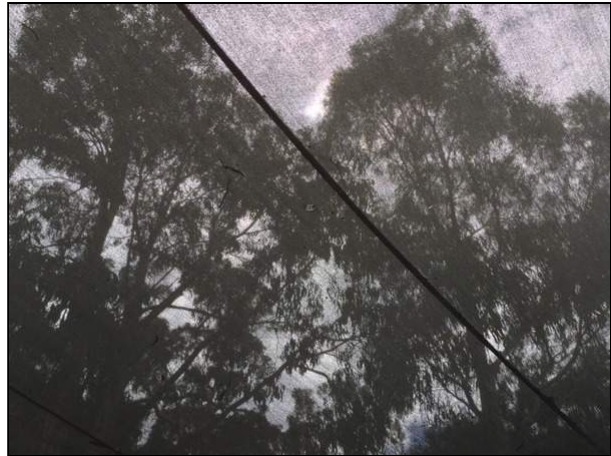
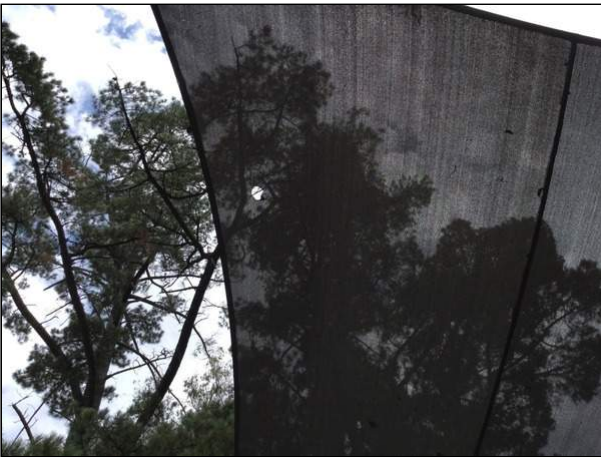
39. Do shade sails/ pergolas, uprights and posts appear to be in good condition?

No

Comment: 2 of the shade sail have holes.

Priority: Low

No
Comment: 2 of the shade sail have holes.
Action Required: Seek services to repair.
Priority: Low

Action Required: Seek services to repair.

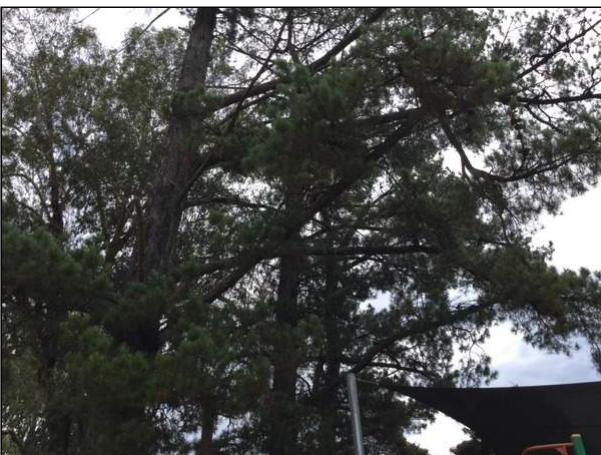
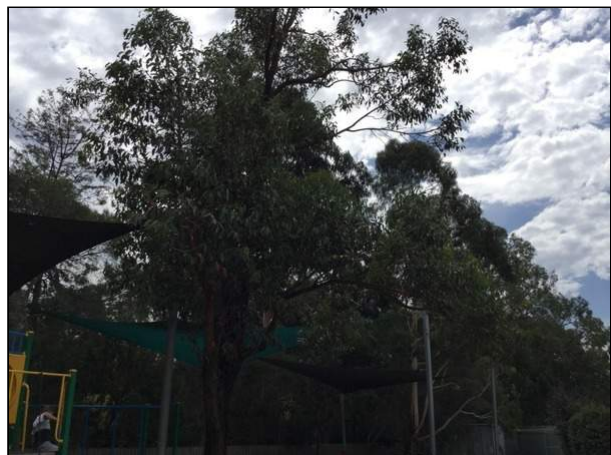
40. Do any trees look to be healthy with no dangerous branches?

No

Comment: All trees appear to be healthy, however they are damaging shade sails.

Priority: High

No
Comment: All trees appear to be healthy, however they damaging shade sails.
Action Required: N/A
Priority: High
